Product Change Notification

MultiTech Conduit[®] IP67 200 Series Base Station

Updated Operating System

PCN 03012022-001 (mPower – MTCDTIP2)

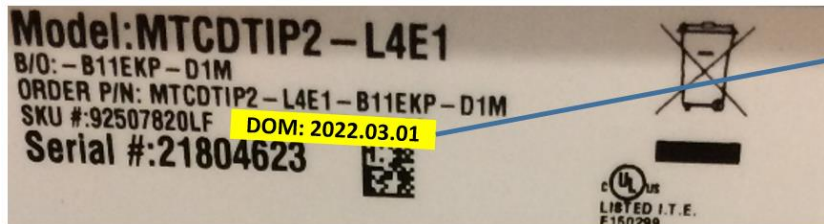
DOM for all devices is identified on the chassis label, see example below.

DOM: 2022.03.01
DOM = Date of Manufacture
2022 = Year
03 = Month (March)
01 = Day

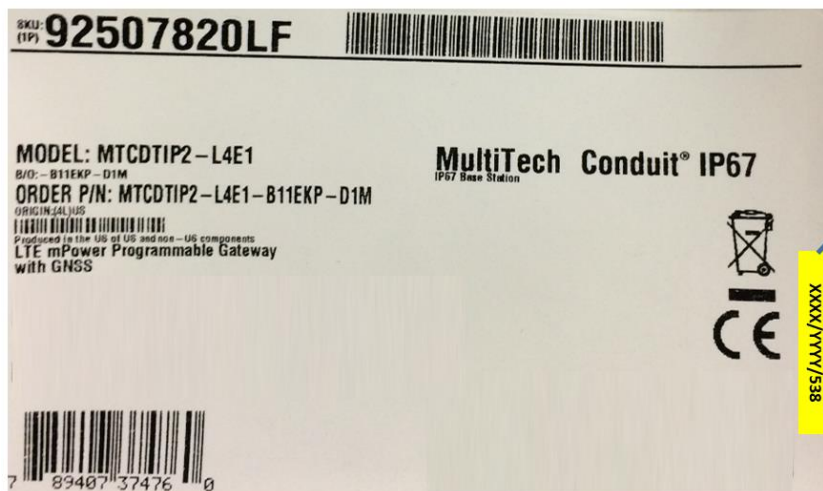
The carton label for each MTCTIP2 device includes an indication of the mPower version included.

XXXX/YYYY/538
mPower Firmware Version
538 = mPower 5.3.8
